Excavations at Peel Park Primary School, Accrington, Lancashire 2011

Draft Report

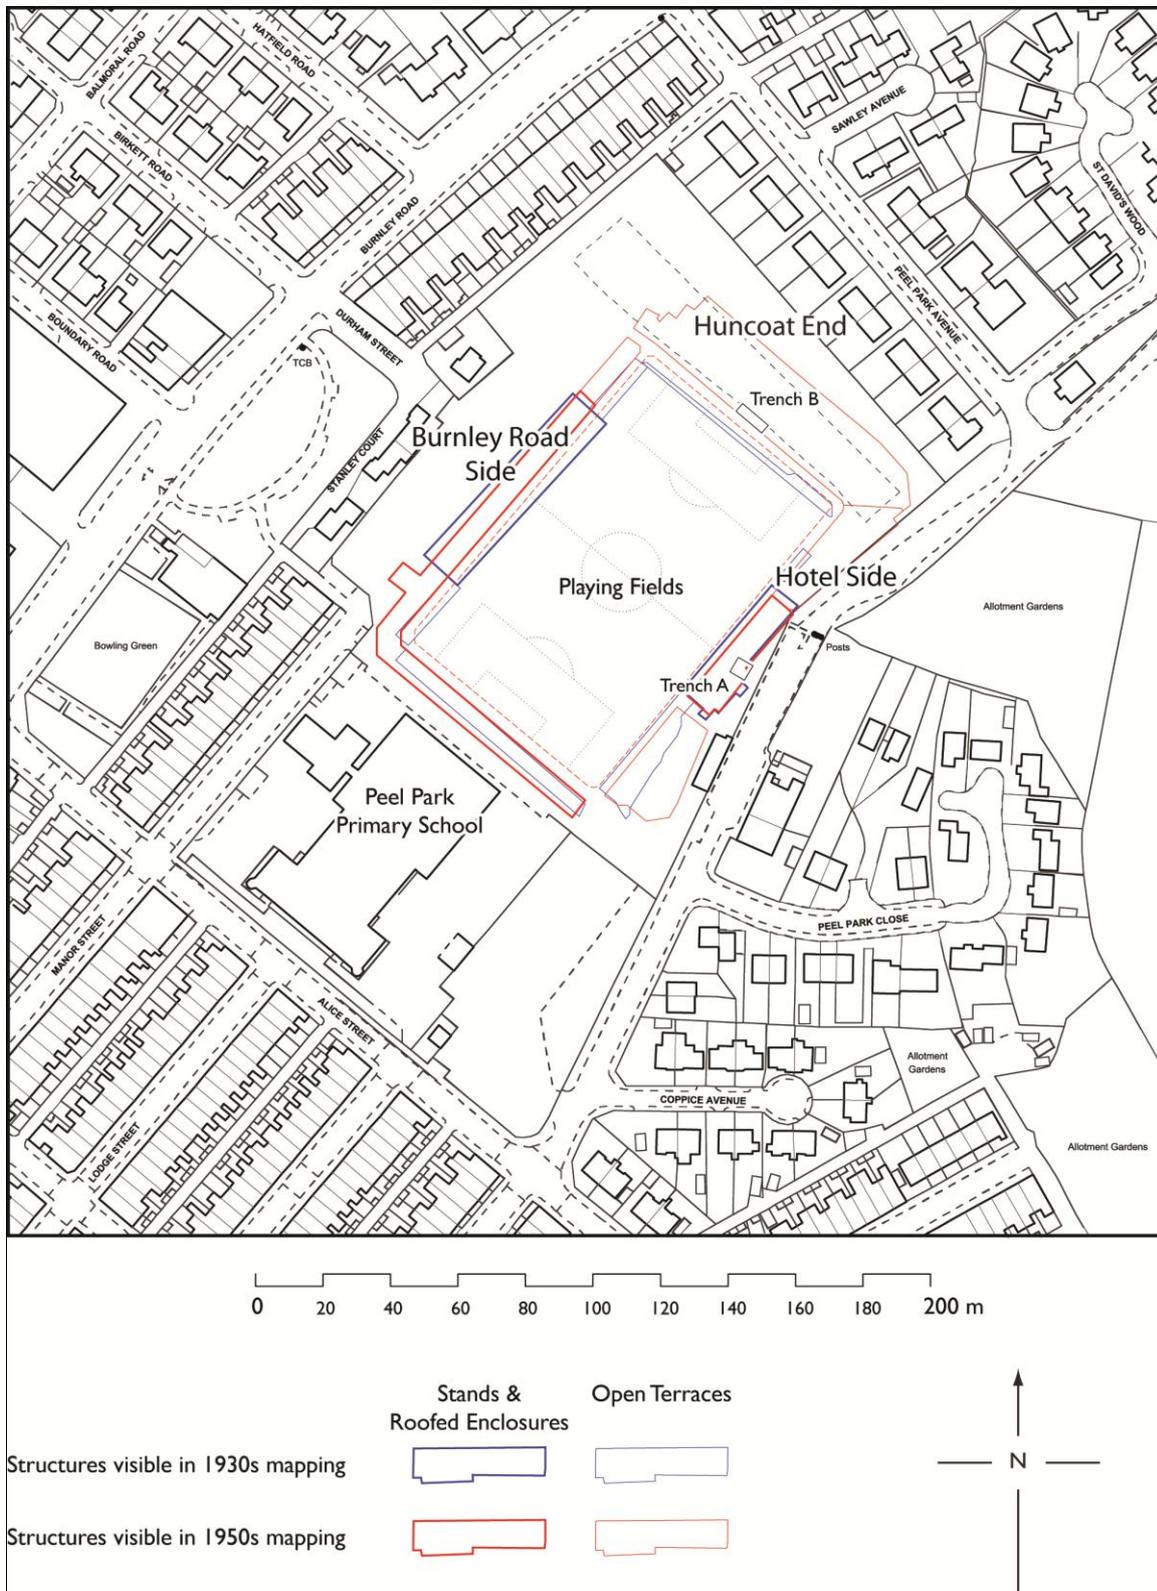
Figure 1.1 location of excavations at Peel Park and map regression evidence for the ground developments

Two areas were excavated over four days. Trench A was a 5 x 5 m area sited over part of the original Hotel side stand and Trench B was a 10 x 3 m area opened over the front edge of the Peel Park Kop at the Huncoat End (figure 1.1).

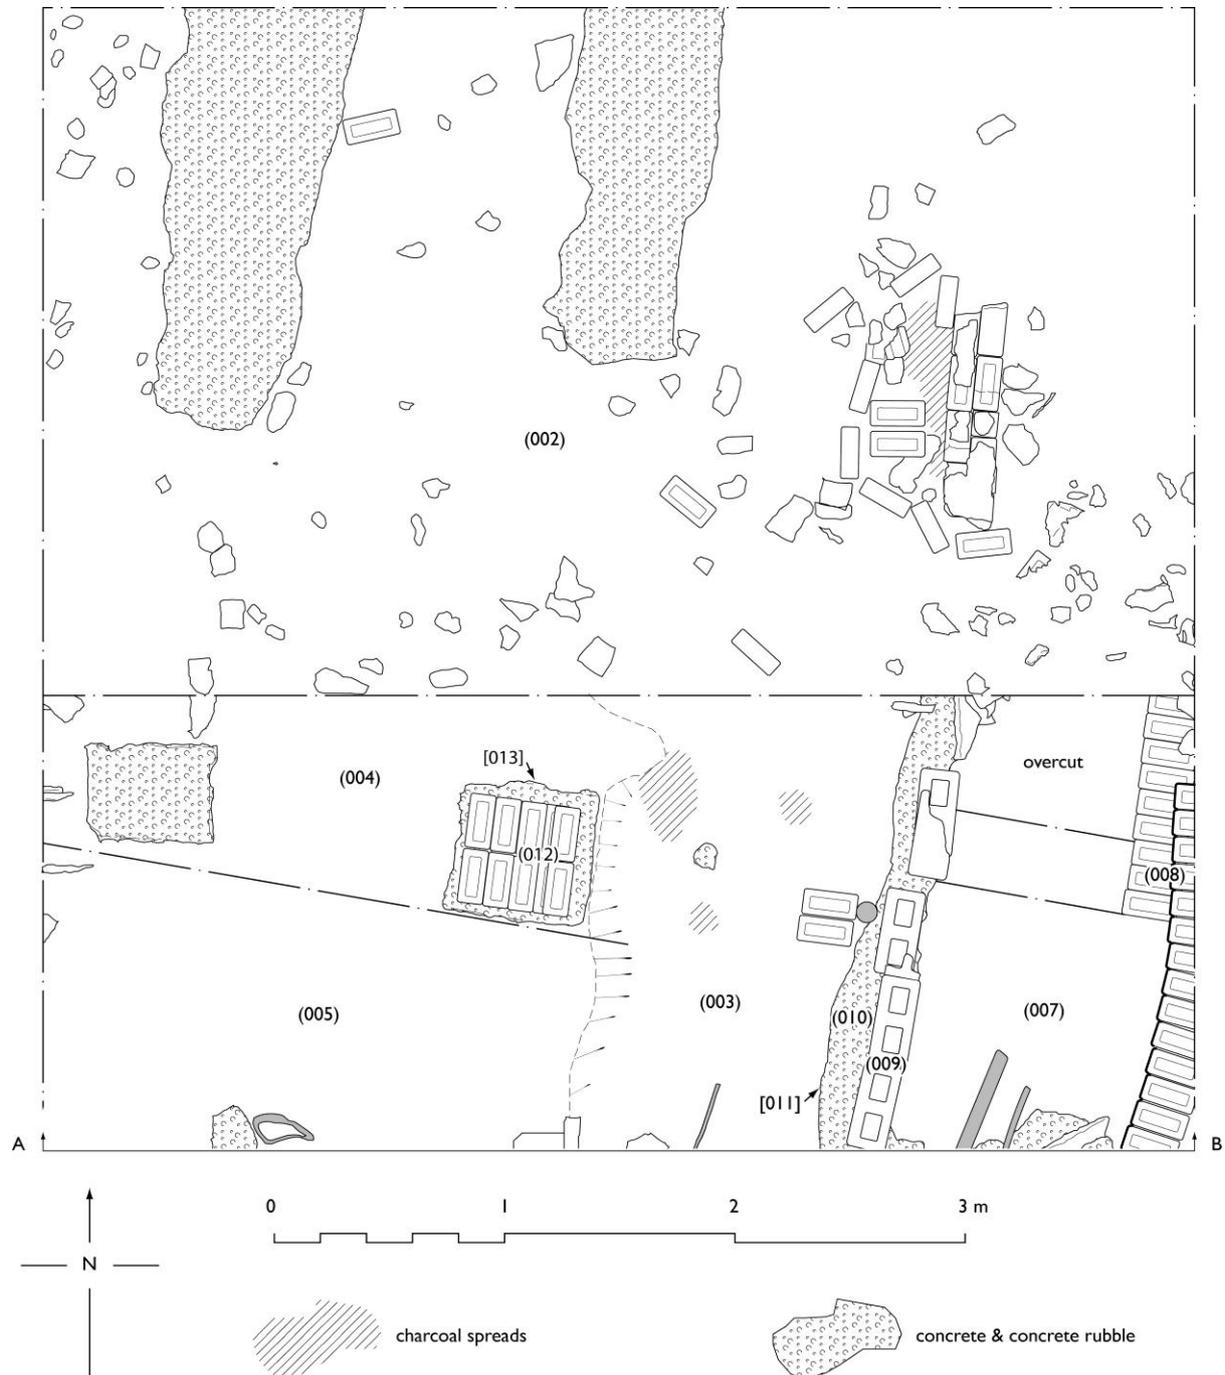
Figure 2.1: plan of trench A after excavation

not investigated. In the unexcavated portion of context 2 there were larger, linear concrete patches which seem likely to have related to whatever structure was supported on these pads (see figure 2.1).

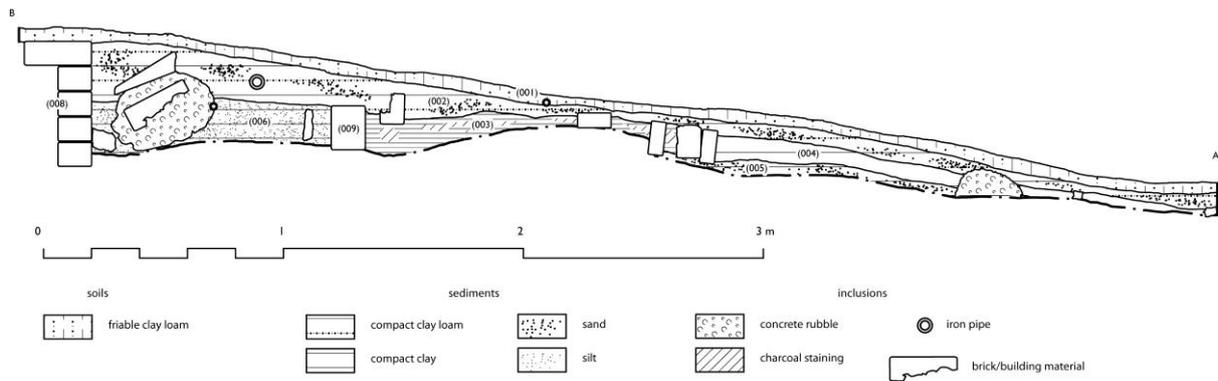
Figure 2.2: section through deposits in trench A along the southern edge of the trench

removed a further spread of debris was identified over the whole excavated area. This was context 2, a very dark grey compact sandy clay loam around 0.30 m deep, which similarly contained large quantities of burnt and broken building material (figure 2.3). At this stage of the excavation it was decided to limit excavation of the layers beneath context 2 to a 2 x 5 m strip along the southern edge of the original excavation area (see figure 2.1). Following the removal of context 2 in this area a complex of surviving structures and further demolition layers was visible. These are reported below with the most recent layers described first (figure 2.2 and appendix 1).

Context 3 was a compact mix of heavily charcoal-stained clay with further demolition rubble: particularly bricks and charred timber. It was between 0.35 m and 0.11 m deep in the excavated section: being shallower towards the west end of the deposit.

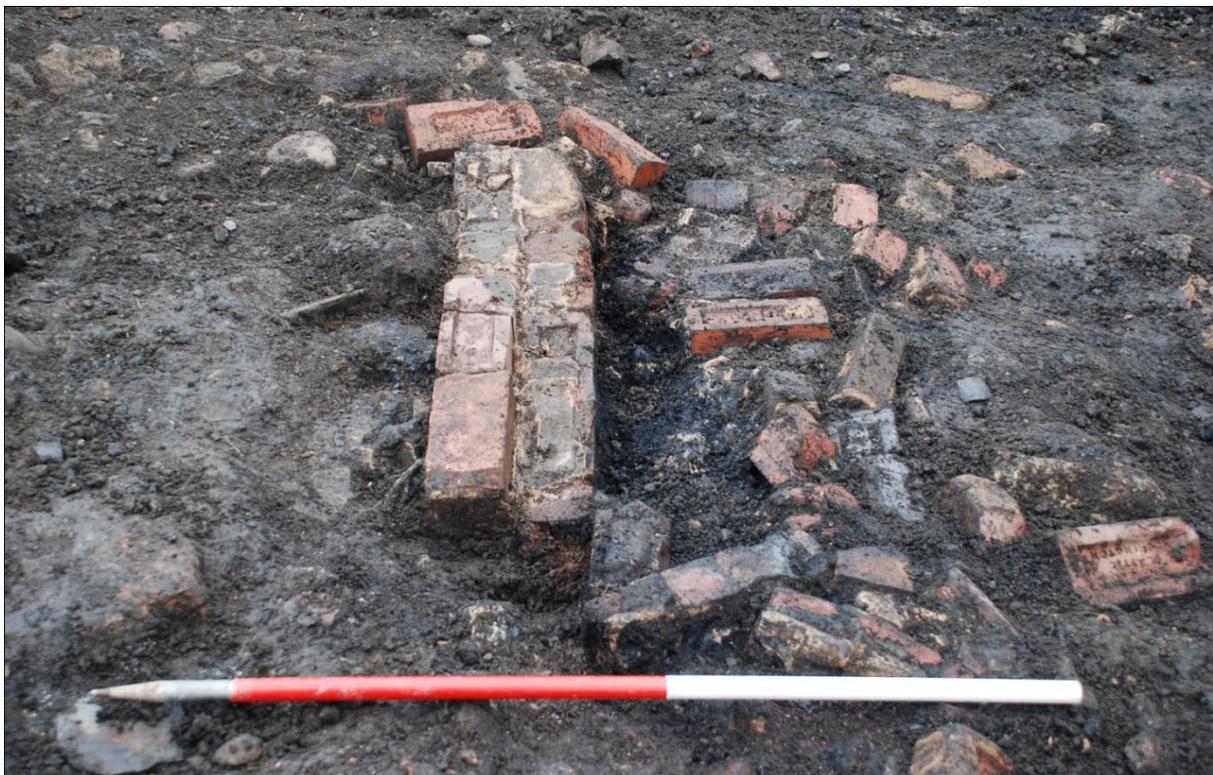
Figure 2.3: demolition rubble and burnt material in situ in trench A. Part of context 2 viewed from the north (Scale = 1 m).

Separating these two deposits, and older than both of them, was a wall foundation, context 9, formed of $0.36 \times 0.18 \times 0.15$ m concrete blocks. Beneath the blocks was a layer of foundation packing, context 10, a mixture of compact brown clay soil and concrete rubble. These wall foundations filled a linear cut, context 11, around 0.42 m wide. The whole wall structure ran on a north-south alignment around 1.2 m from the eastern edge of the excavated area. Large sections of mortared brick-work were found within context 2 on this alignment (see figure 2.3) and these almost certainly represent the demolished remains of the upper part of this wall.

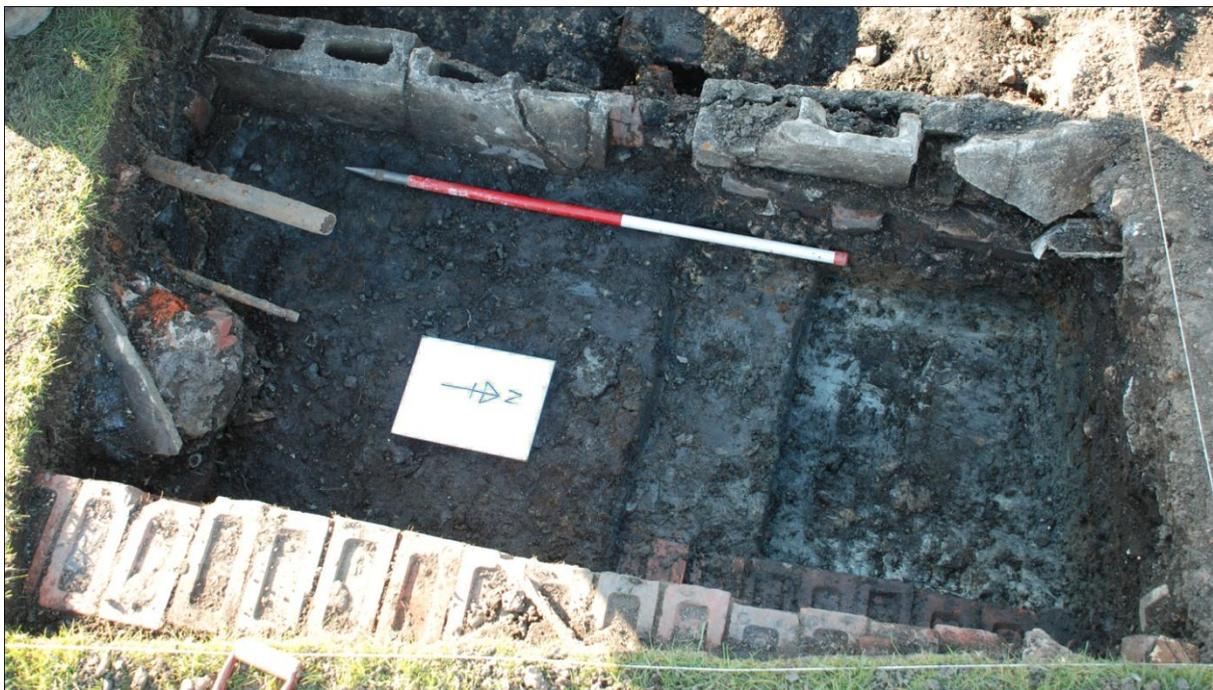
Figure 2.4: trench A from the east showing both wall foundations: context 8 and, behind the scale rod, context 9 after the removal of the demolition rubble in this area (scale = 1 m)

To the east of context 9, and also earlier than context 6, were the much more substantial brick foundations of another wall. This wall, context 8, survived as at least seven courses of red Accrington NORI brick, and was wide enough to extend beyond the eastern edge of the trench. The uppermost surviving layer was a header course; beneath this was a stretcher course and then another header course. This in turn was followed by another three stretcher courses before there was an off-set header course which broadened the base of the foundation by around 0.2 m. The wall foundation slot was not clearly visible without removing the bricks, which was not attempted. This large wall ran on a north-south alignment parallel to the context 9 wall described above.

The excavated remains within trench A are clearly the lower layers of the Hotel side stand. In particular, context 8 can be seen to be the foundations of the original rear wall of the stand. Context 9 is likely to represent a later sub-division within the stand. All of these features are buried beneath extensive debris from the 1972 fire which has trapped and preserved both surviving fixtures from the stand and artefacts that had been deposited on its surfaces.

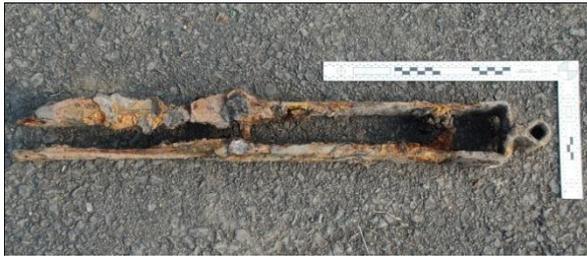
Figure 3.5: Iron strap hinge from access gate to the stand, context 2, trench A. Scale 0.4x0.2 m

The iron objects from the site fall into two broad classes. There are many architectural and building fittings ranging from nails to large strap hinges and roof fittings. There are also objects directly associated with playing football, particularly the pegs used to fasten down goal nets. The strap hinge from trench A is likely to be from one of the access gates into the stand. Several of the fittings and bolts still retain traces of red and white paint. Goal net pegs come from both excavated areas: although they are most plentiful in trench B behind the main goal mouth at the Huncoat end. There are historical photographs (Whalley 2001, 87) showing schools football taking place prior to April 1972 on reduced size pitches with goals in front of the original stand (i.e. at right angles to the main pitch alignment), which probably explains the presence of these pegs in trench A. The whitewashed steel pipe from trench B is also likely to be a goalmouth fitting: in this case probably part of one of the stanchions behind the main goalposts.

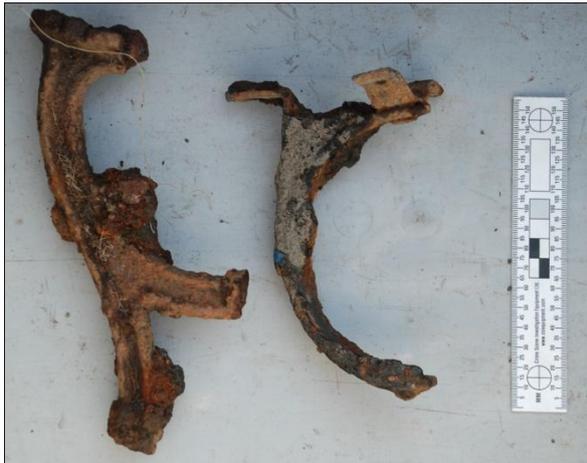
Figure 3.6: Iron seat support and gutter bracket with paint traces, context 2, trench A

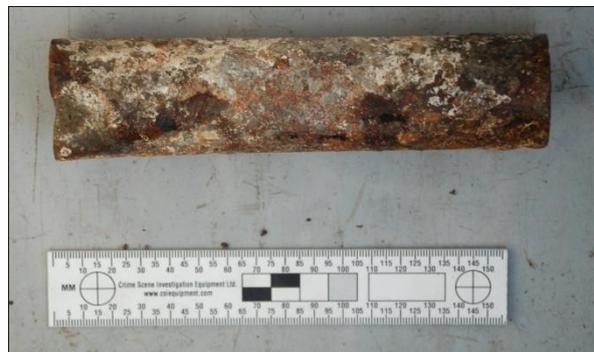
Figure 3.8: Iron pipe with whitewash traces: probably part of a goal stanchion, context 101, trench B

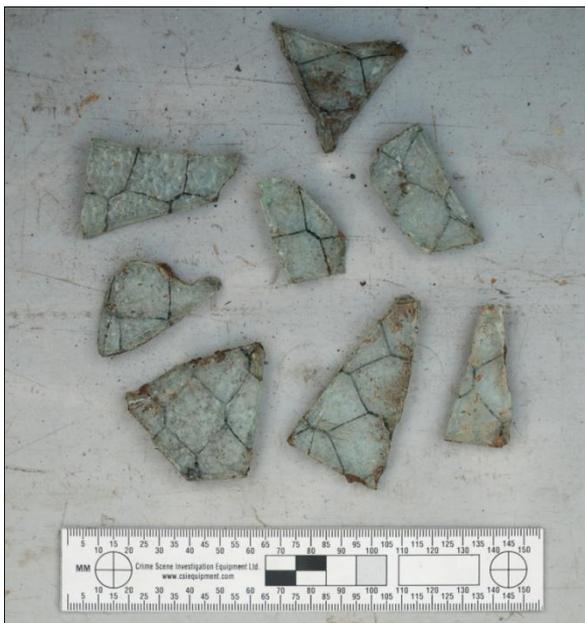
Figure 3.15: wired safety glass, context 102, trench B

Glass finds were dominated by clear bottle glass and, even more particularly, by clear window glass. There was some wired safety glass from both trenches, although this

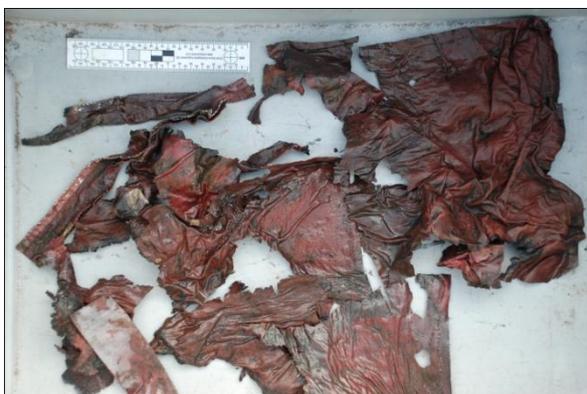
Figure 3.17: PVC seat covering from context 3, trench A

As with metals and glass there are a number of plastic finds which clearly relate to the built structure of the stands. Perspex glazing and linoleum is present but infrequent. There are also some quite substantial fragments of dark red PVC from demolition layers in trench A which is likely to be the remains of seat coverings. Other plastic finds were the remains of more portable artefacts. Polystyrene drinking cups were relatively common in the lower destruction layers of trench A. Of particular interest from trench B are the 27 fragments of a green plasticised board with the remains of football pitch markings still visible. This is the remains of a portable tactics board.
